Garmin Nuvi 2589LMT Microphone Replacement

A simple guide to replace your Garmin Nuvi 2589LMT Microphone.

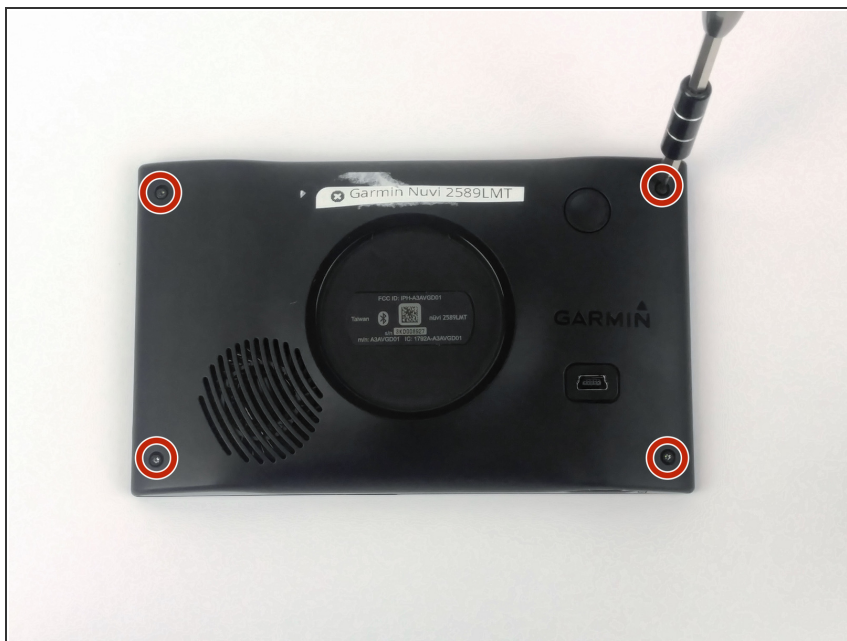
Step 1 — Back Panel Assembly

- Using the T5 Torx Screwdriver, remove all 4 of the 5.7mm screws from the back of the device.

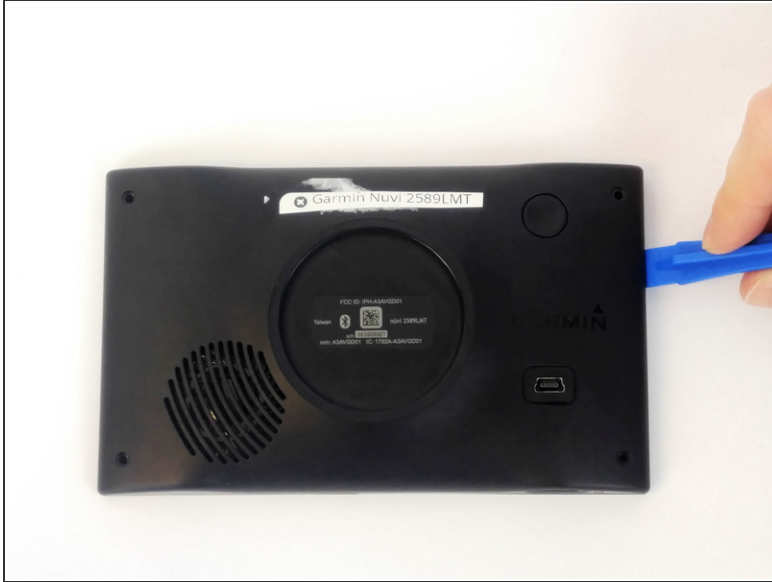
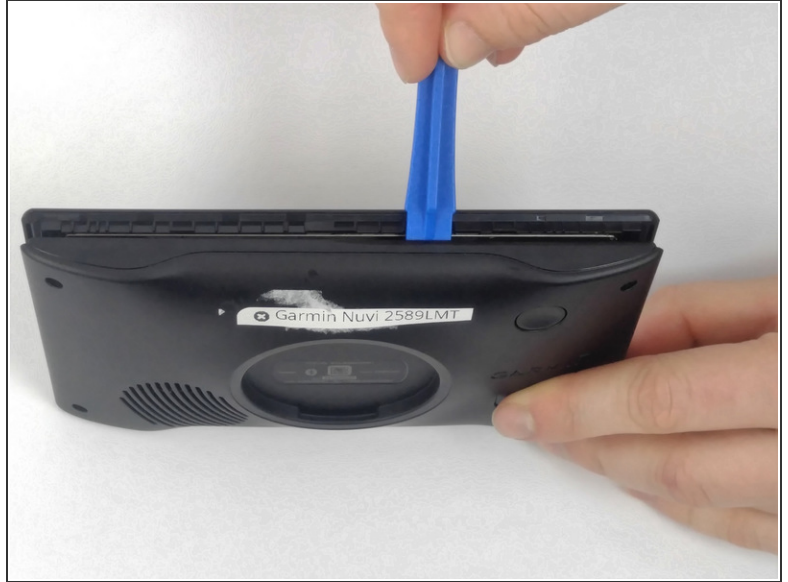
Step 2

- Using the plastic opening tools, pry the shorter sides of the device apart.
 - Once a gap has formed at the top of the device, insert the opening tool into the gap and slide it along the top of the device. Repeat for the bottom edge of the device to separate the LCD screen from the back.
- ⚠ Do not disconnect or tear the ribbon wiring, located at the bottom of the motherboard, when removing the back of the device.

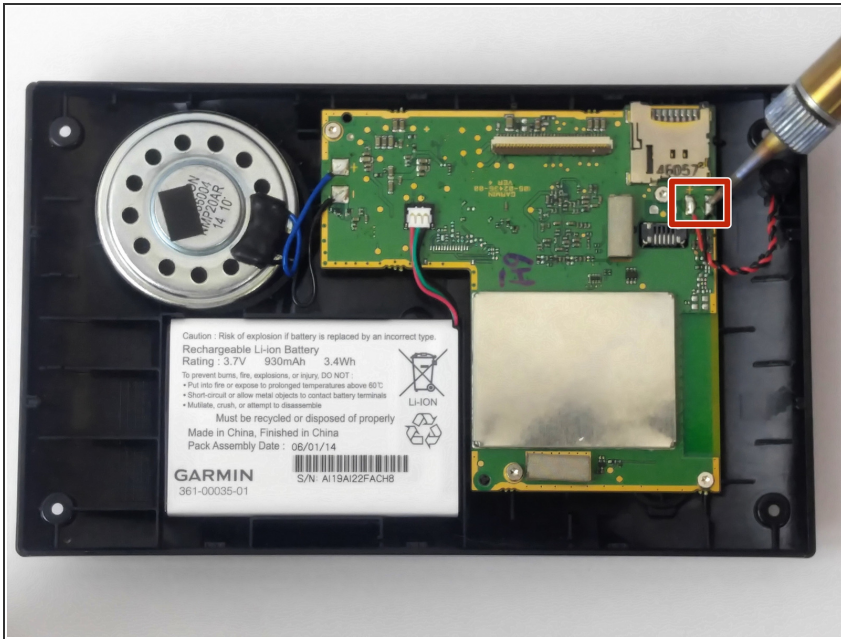
Step 3 — Microphone

- Using a soldering iron, desolder the wire connection at the two soldering points between the microphone and the motherboard to remove.
- ❗ Learn more about soldering and desoldering connections [here](#).

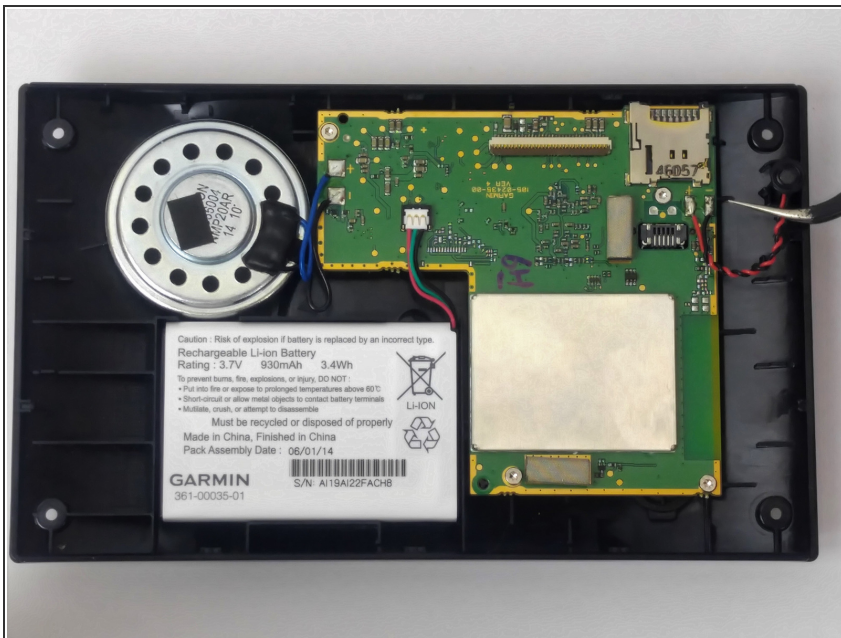
Step 4

- Using the angled tweezers, grab the microphone wires and gently pull to remove the microphone from the device.
